Availability and Consumption of Wooden Resource for the Construction of Late Medieval Roof Structures in Finland

This work is part of an on-going project "Deciphering roofs: Historic Timber Structures of Finland and Architectural innovations in Late Medieval Europe" 2020-2024 (PI Panu Savolainen) and was funded by the Kone Foundation.

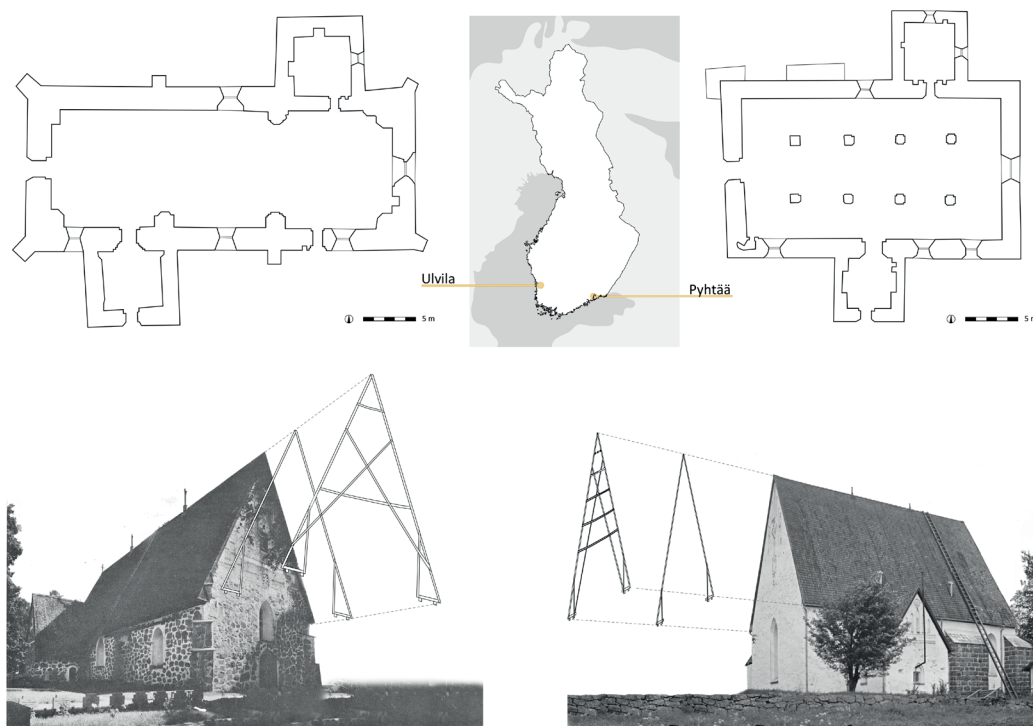
Figure 1. Ulvila church (left) and Pyhtää church (right) location in current-day Finland with their floor plans and roof truss scheme. Map: Franziska Dalheimer. Floor plans: Franziska Dalheimer, based on Hiekkänen 2007, 266, 464. Photograph of Ulvila church: Sven Raita, 1955, Satakunta Museum's collections. Photograph of Pyhtää Church: unknown author, 1926, Finnish Heritage Agency. Both photographs modified by Franziska Dalheimer.

trusses. There are altogether 34 nave trusses in Ulvila church, including four trusses without scissor beams and collar beams in the gable walls (Figure 1). Pyhtää church has 22 nave roof trusses, including two of them in the gable wall. Both churches had at least one wooden predecessor at the same location.¹⁵ The similarities between the two churches provide an incentive for a comparison of their wooden resource consumption and availability during the building process. Despite their similarities, differences in the settlement history of the town of Ulvila and the parish of Pyhtää may suggest varying demands for wooden building materials.

The sacristy is the oldest part of the stone church constructed most likely in 1495,³⁷ since it was a common habit in Finland to first build the stone walled sacristy. Only later on the main nave (1500–1501) and porch (1509–1510) were built to the south of the sacristy (Figure 1) most commonly replacing a wooden predecessor church.³⁸

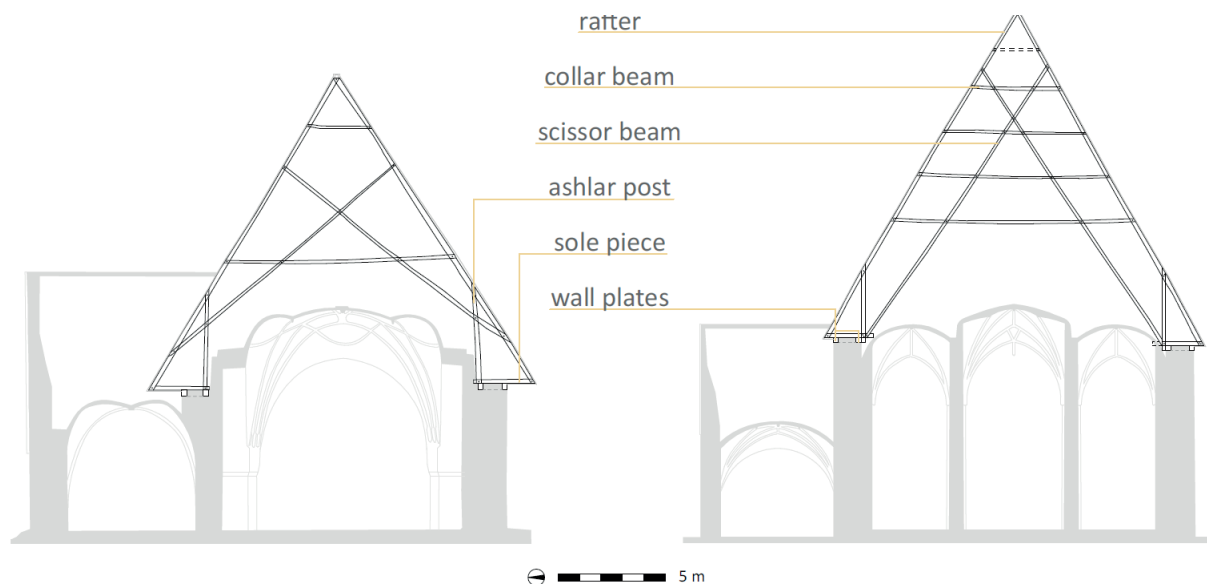
Figure 2. Nave roof structures of Ulvila church (left) and Pyhtää church (right). Drawings: Franziska Dalheimer & Ilari Aalto, church rooms based on Otto Iivari Meurman and Mildred Grönholm, 1913, museovirasto arkisto & Carolus Lindberg (?), 1915/16, Aalto University Archives.

The original medieval roof structures provide information on the resource consumption during the construction phase. This section begins with a reconstruction of the volume and weight of the whole nave structure by surveying each structural member, grouped in member types (Figure 2), and subsequently scaling the weight and volume up to one whole roof truss. The weight can only be determined through the identification of the used wood species, which can be used to infer the preferences of the builders or the availability of certain wood species. Lastly, the physical appearance of the timber members reveal insights into its manufacturing process and can be used to reconstruct the original dimensions of the used trees.

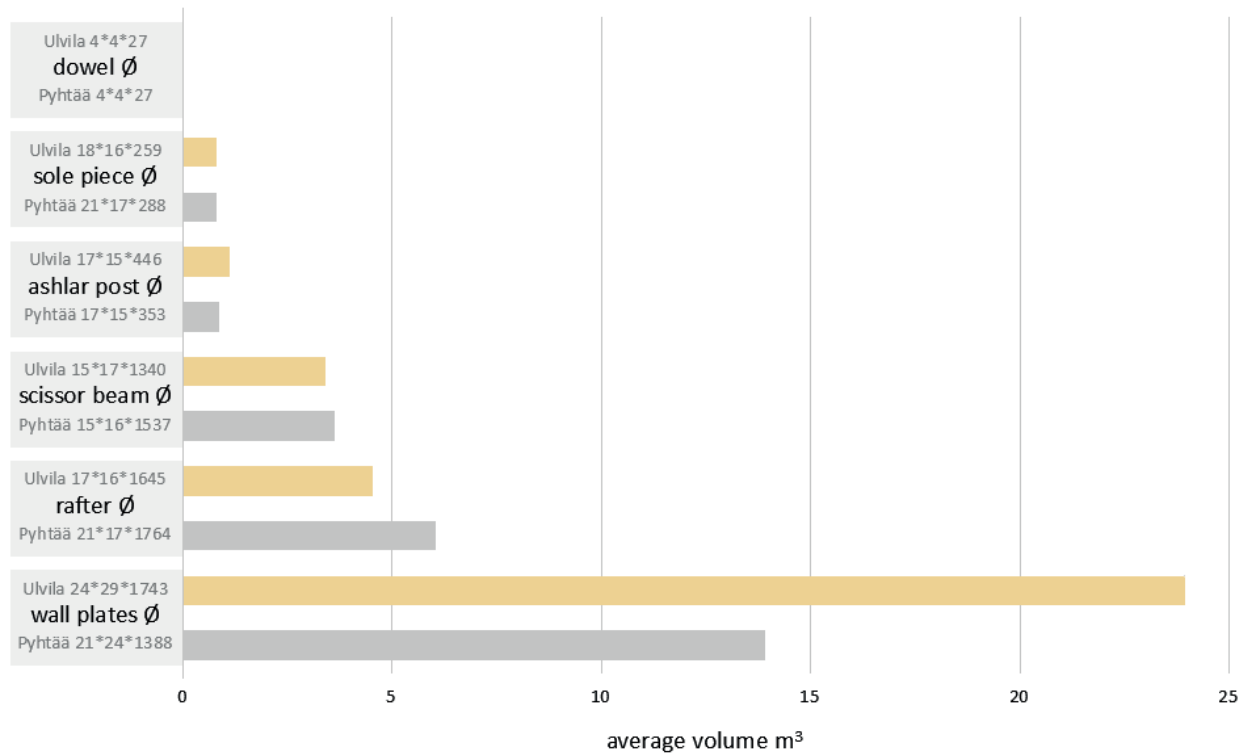
Figure 3. The average volume [m³] and average dimension [cm - height*width*length] of comparable nave roof structures of Ulvila church (yellow) and Pyhtää church (brown). Measured on a height closest to the church stone walls, excluding wall plates connections and collar beams. Graph: Franziska Dalheimer.

gables and cannot be accessed. The weight breaks down into the calculation of the volume of the different structural member types and wood species as follows. Figure 3 shows a simplification of the average volume [m³] of all comparable structural members, all measured at their points closest to the church walls, where the dimensions have a higher diameter, since the truss members tend to get thinner towards the top at Pyhtää church. This is not the case for all the beams in Ulvila church. The circumference of some rafters is smallest at the height close to the highest collar beam. Many rafters show a doveled connection at this position to lengthen an apparently short rafter with an extension beam (Figure 4).

Each structural member of each type is comparable in their dimensions with respect to height, width, and length in both churches. It can be assumed that these were purposely chosen dimensions by the master builder. Two of the member types were excluded from Figure 3. The first ones missing are the approximately 1 m long beams, which connect the wall plates, since they were not accessible in Ulvila church. The second ones missing are the collar beams since their length and numbers are not comparable (Figure 1). We chose to compare the volume and not the weight in this case since the weight is influenced by the wood species. The largest proportion have the wall plates (Figure 3) with a higher amount of used timber in Ulvila, which is influenced by the 10 meter

used. Many of Ulvila's scissor beams, rafter and collar beams were not completely rectangularly hewn but still have at least one or two round corners. The ashlar posts even have up to three or four round corners. The dimensions in Figure 3 show that the ashlar posts in Ulvila church's nave are comparable in width and height to the ashlar posts in Pyhtää, which means that younger, smaller diameter trees were chosen, as long as they were of certain dimensions. On a few members in Ulvila church traces of bark can even be found on the round corners or show galleries of phloem-feeding insects, located immediately under the tree bark (Figure 7). These insects invade weakened or recently dead wood but remain in the wood only until the phloem is either consumed or dried out. In this case, the presence of these galleries indicates that the trees were not debarked before use and were prone to insects while left to dry short-term before manufacturing.

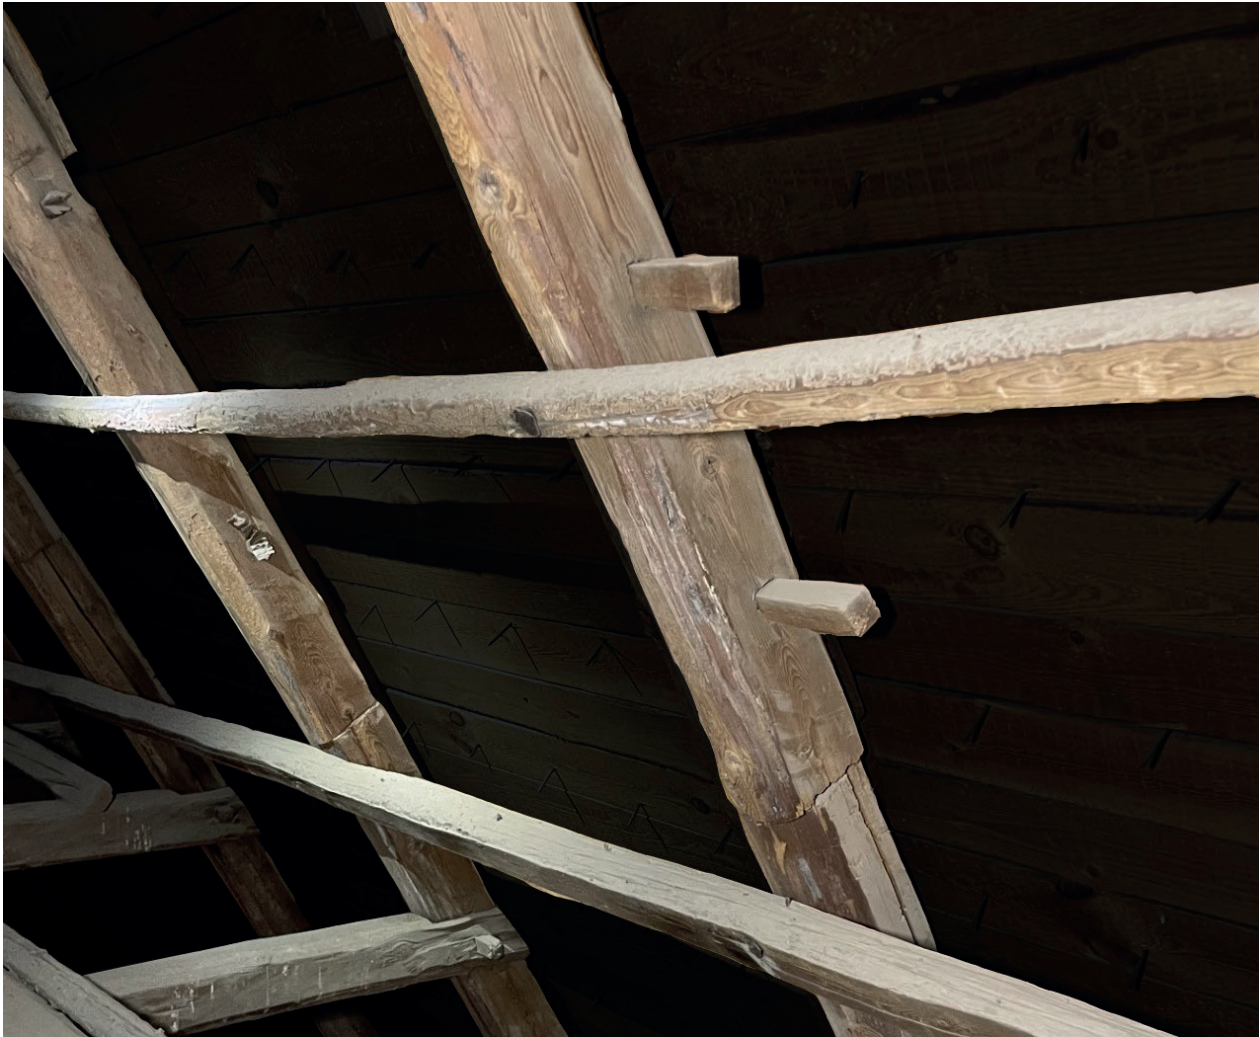
Figure 4. The rafter extension in the nave roof structures of Ulvila church. Photo: Laura Laine, edited by Franziska Dalheimer.

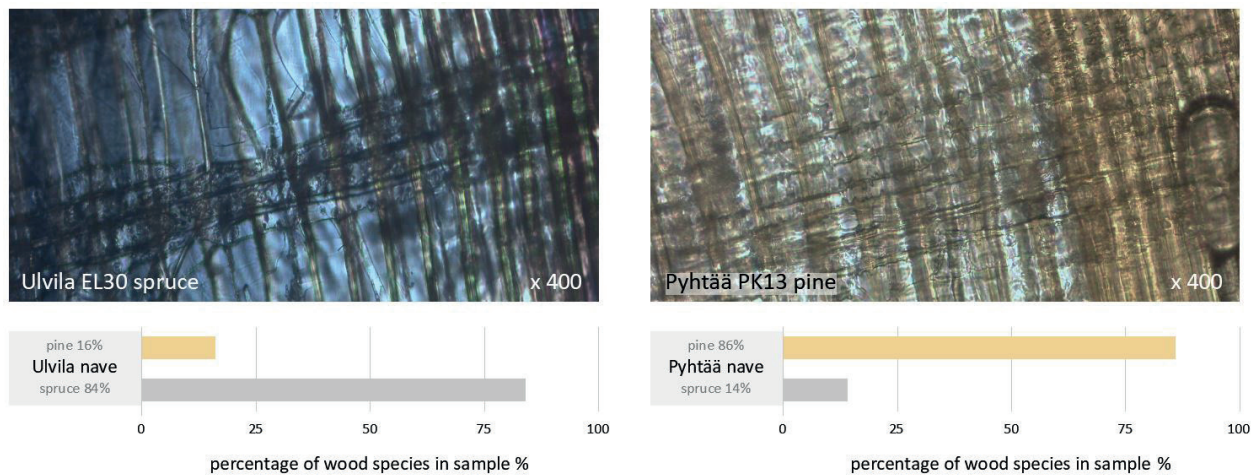
Figure 5. The identification of the wood species in the nave roof structures of Ulvila church (left) and Pyhtää church (right). Graph and photos: Franziska Dalheimer.

Figure 5 shows the proportion of identified wood species in both church naves. All structural member types were sampled in an equal number, except for the collar beams in Pyhtää church due to accessibility. There were ten samples in total taken of all rafters, ten of all scissor beams, ten of all sole pieces and ten of all dowels, twelve of all wall plates and two samples of the collar beams from Ulvila church. Additionally, two horizontal beams which were resting in the gable church walls without being connected to the structural beams were sampled in Pyhtää church but were absent in Ulvila church.

The 32 samples of the Ulvila church nave roof structure were microscopically identified as 84% spruce and 16% pine, of which all the wall plate timber was pine. The dowels were equally pine and spruce, but no other species were found. The 34 samples of the Pyhtää church nave roof structure were 86% pine and 14% spruce. The share of spruce was not concentrated in a certain member type, but was identified in a sole piece, an ashlar post, a scissor beam and in a rafter. The analyzed dowels and wall plates in Pyhtää were all made of pine.

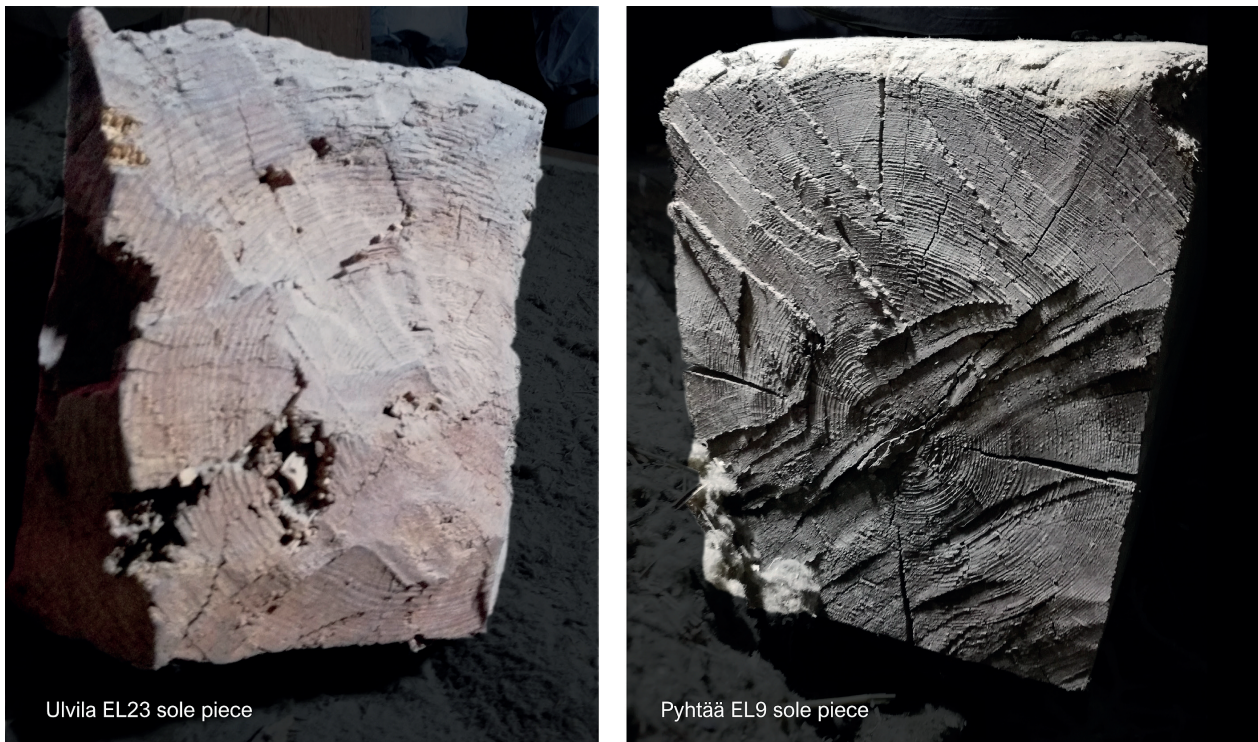
Figure 6. The profiles of sole piece (EL23) at Ulvila church nave (left), sole piece (EL9) at Pyhtää church nave (right). Both members are rectangular hewn and not cleaved timber. Photos: Franziska Dalheimer.

The physical appearance of the structural members can provide additional information. The shape of the timber tells us about the possible size of the original tree and from which part of the tree the timber originates. Cleaving was a common technique for preparing wooden building material during the medieval times especially for churches in Sweden,¹⁸ but this is not the case for the structural members of the Ulvila and Pyhtää church naves. The profiles of the timber (Figure 6) and of the heartwood, which is not visible on the surface, show that whole and uncleaved timber was

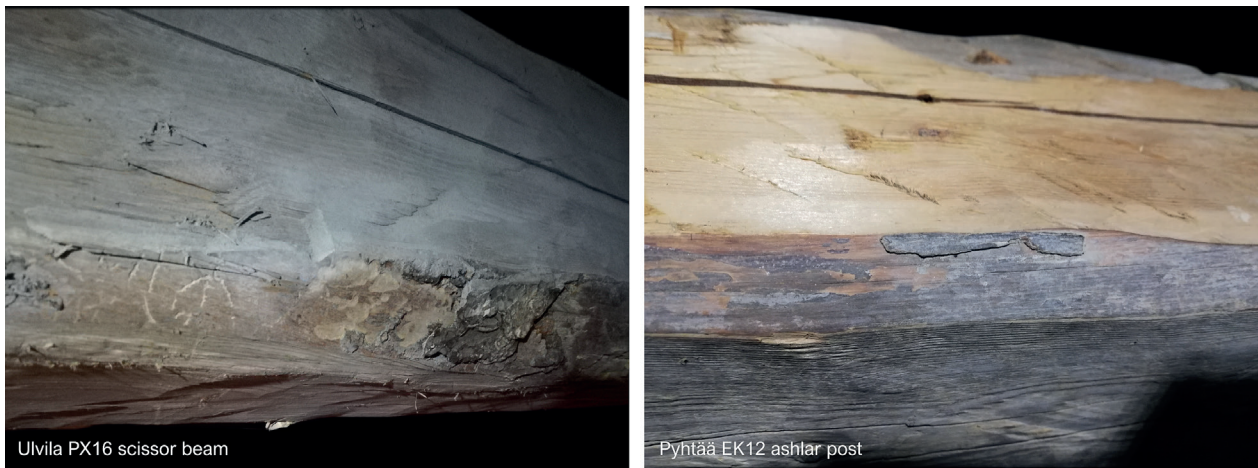
Figure 7. A scissor beam (PX16) with bark and insect galleries at Ulvila church nave (left), ashlar post (EK12) with remaining bark at Pyhtää church nave (right). Both members are not rectangularly hewn but have round edges. Photos: Franziska Dalheimer.

This is opposed to the physical appearance of the roof structures of the Pyhtää church nave. Only a very few members can be found with one or more round edges and although there still might be bark left in those cases, galleries of phloem-feeding insects are absent. This suggests that the timber was equally not or only poorly debarked before processing, but not invaded by insects. The absence of the waney edge in the timber in Pyhtää suggests that the trees were larger compared to Ulvila, with enough material to craft the timber from.

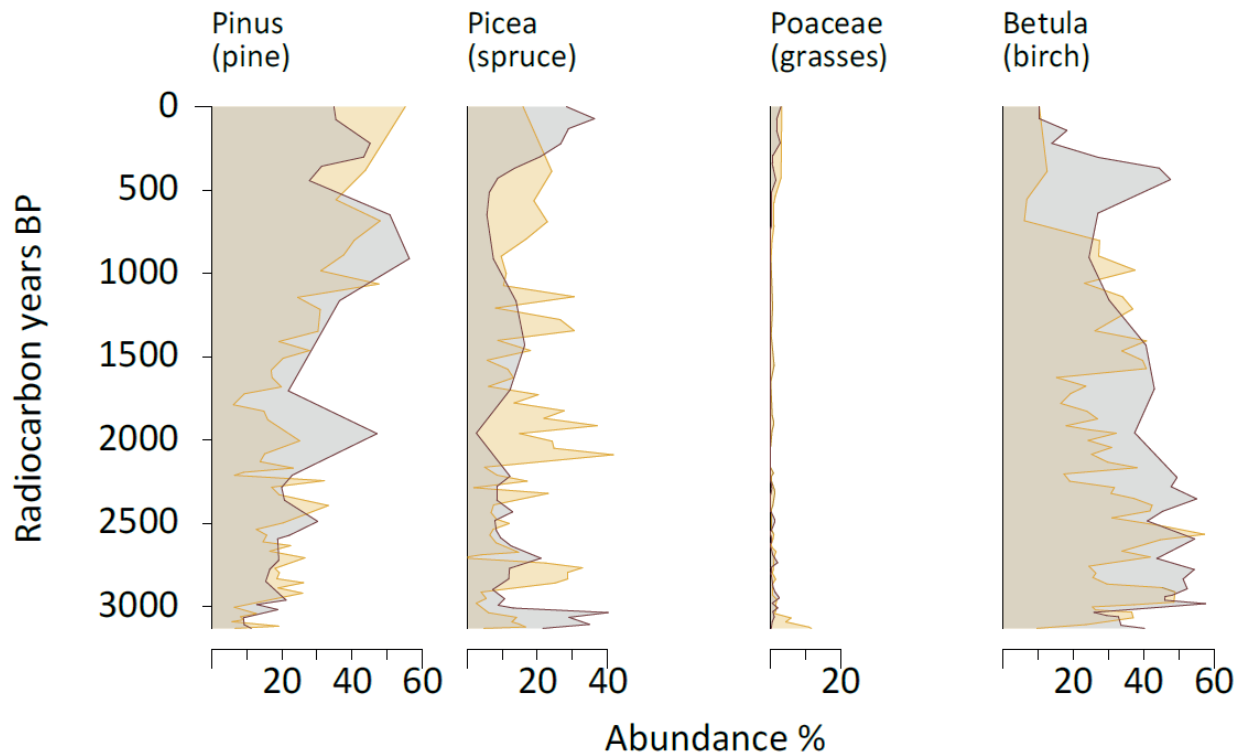
Figure 10. Selection of pollen concentrations of Siikasuo (gray) and Tullerinsuo (yellow). Graph: Franziska Dalheimer based on Irmeli Vuorela, "Lounais-Suomen varhaismetallikautinen asutus ja viljely siitepölyanalyysin valossa", *Karhunhammas* 13, (1991): 8–11.

The pollen diagrams (Figure 10) show several changes in the soil's pollen concentration around the radiocarbon years BP 500, when the current stone church in Ulvila was built.⁴⁰ The up to 150 years before that are equally considerable, when Ulvila appeared first in medieval sources and oldest archaeological findings also point to this time.⁴¹ The data of the pollen analysis should be considered with caution in many regards. High values in pine or spruce are often caused by the characteristics of wind pollinated species and are not evidence of the presence of large pine forests. This also means that insect and self-pollinated species are underrepresented in these sediments. Lastly, the exact years of pollen accumulation are not accurate. Sediment dates may vary from decades to centuries depending on the accuracy of the radiocarbon dates, the pollen accumulation rate, and the thickness of the sediment sub-sample analyzed.⁴²

The first category (Figure 10) of *Picea* (spruce) and *Pinus* (pine) can be considered the most informative, since it equally provides insights into agricultural and building activity. A decrease around the time when a marketplace with settlements were established in the 1340s in Ulvila could indicate that the surrounding forest was cleared and cultivated, using slash-and-burn methods, with the felled trees used for construction. The most common dwelling type at this time was a log-frame smoke cottage made of pine logs. Since Ulvila is located close to the Baltic Sea, long and straight pine timber might have also been used for ship building.⁴³

The last category shows *Betula* (birch). This wood species is not directly linked to the building material of pine and spruce of the roof structures. However, in the Siikasuo sample it shows an initial increase in the pollen concentration, which could have been caused by birch regeneration on formerly used land, in logged areas, or after forest fires that tend to increase with human presence. In addition, birch was a common choice for firewood, which might explain the decrease in the birch pollen concentration close to settlements, even if not necessarily used directly as building material.
